## **RKD 5-2 Specifications**

**Infinity Drain**

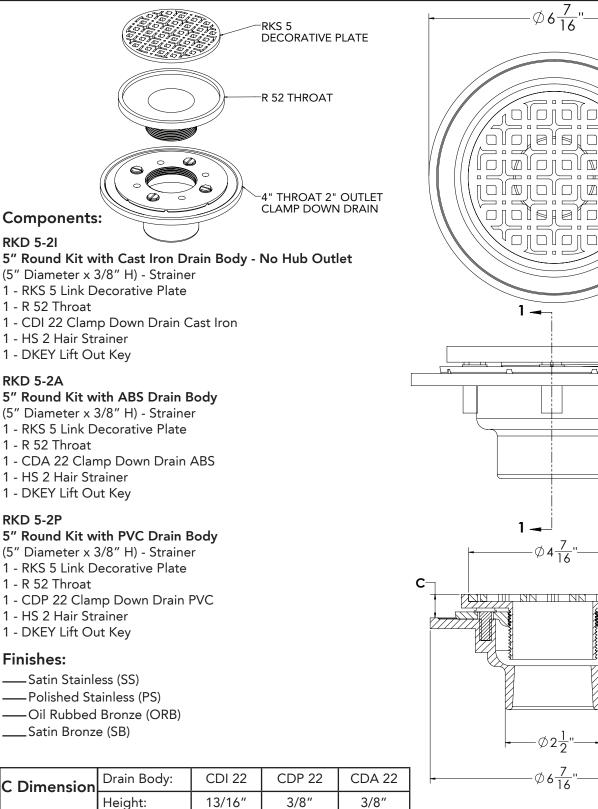
$\phi_{6\frac{7}{16}}$
